BELLEVUE  
COMMUNITY  
SCHOOL  
DISTRICT

**BELLEVUE COMETS**

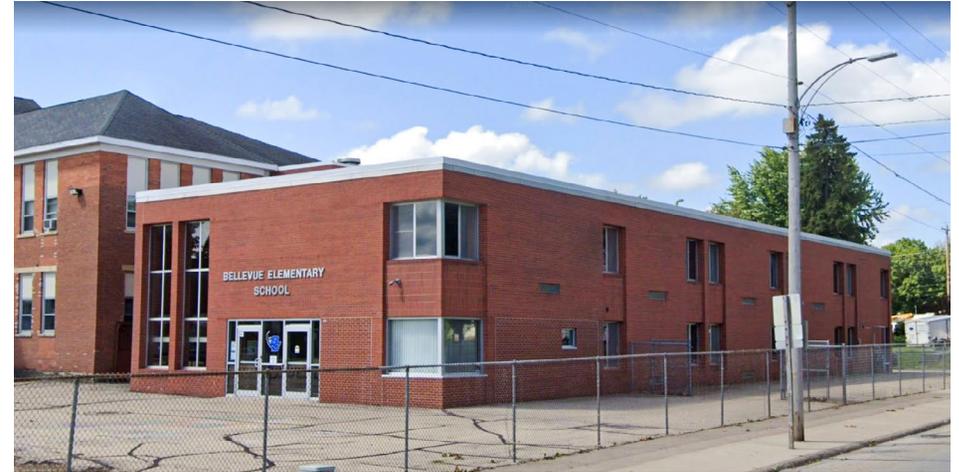
In several classrooms there are charging stations for student laptops. More power and receptacles should be added in these areas to accommodate for charging station needs.

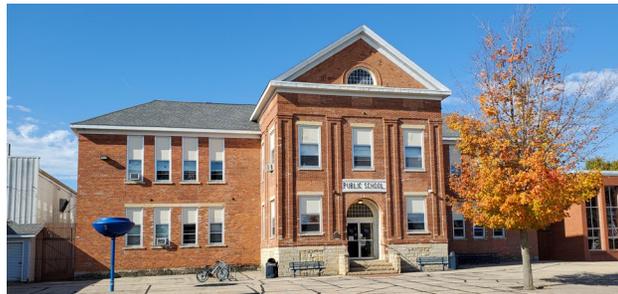
Fig. 3: 2021 photo showing present day conditions of the existing building.

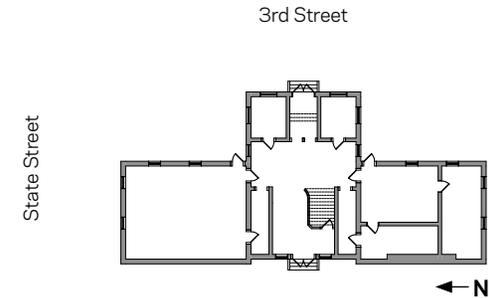
Fig. 4: 1848 floor plan.

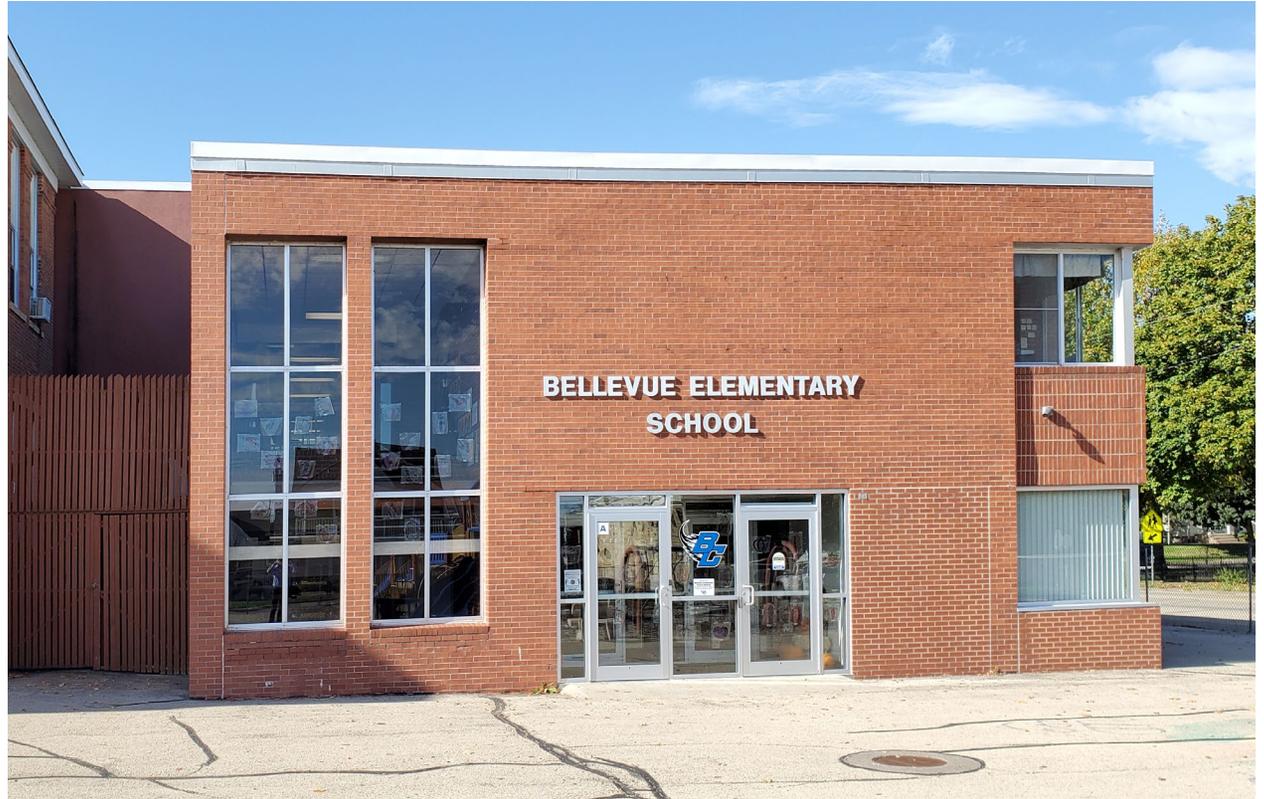
Fig. 15: The 2013 first floor administrative office renovation is slightly visible by variations in brickwork and brick joint lines. The 2005 elevator tower addition is visible in the background, tucked between the 1848 building and the 1973 addition.

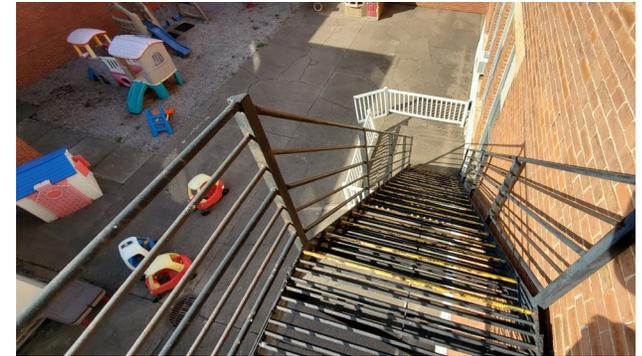
Fig. 1: Fire egress stair from the 1848 original building exits into an intervening space (enclosed courtyard), which requires re-entry into the 1960 & 1973 additions to exit to the public way (street). This is not allowed by code.

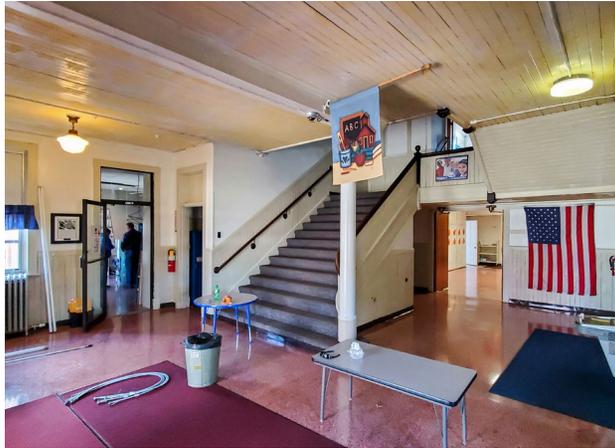
Fig. 7: The central stair in the 1848 building is open to adjacent spaces and does not have any fire separation between the basement and upper floors, creating a three-story space. No other stairs in this portion of the building are compliant with egress or fire separation.

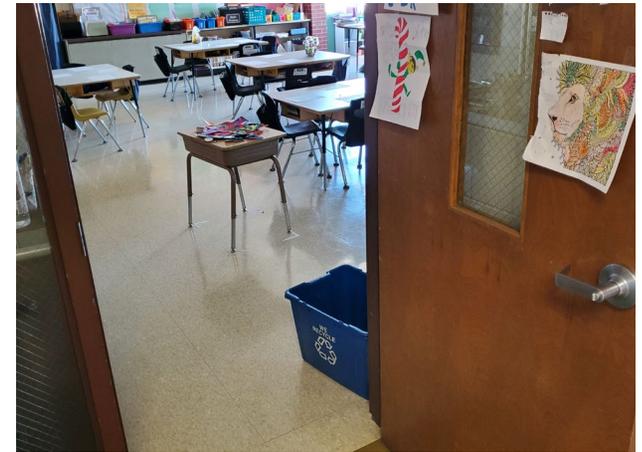
Fig. 8: Wire glass windows in the 1973 addition are no longer allowed by code due to the tendency to shatter and cause injuries.

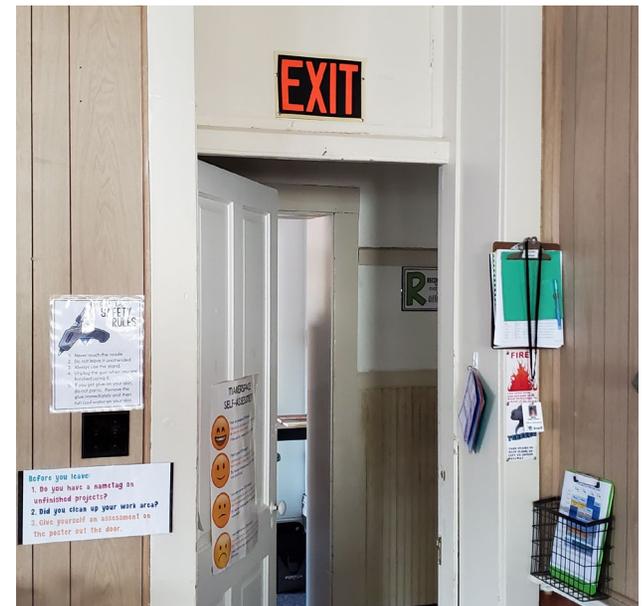
Fig. 6: No doors or windows from classrooms to corridor spaces are fire-rated. Rated doors are required in educational buildings that do not have an automatic sprinkler system installed.

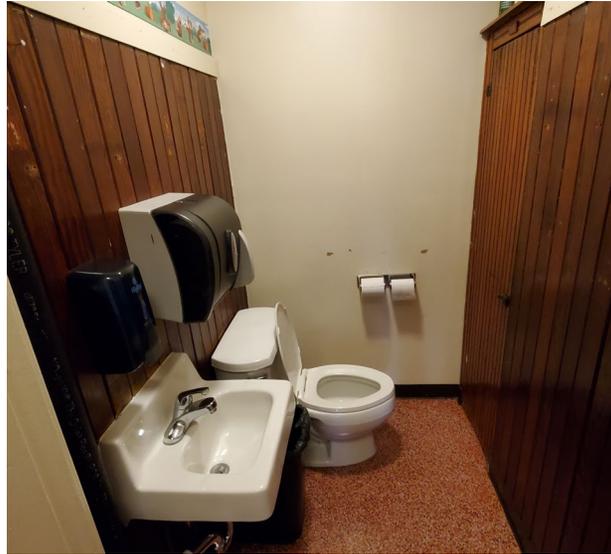
Fig. 10: A non-accessible restroom in the 1848 original building.

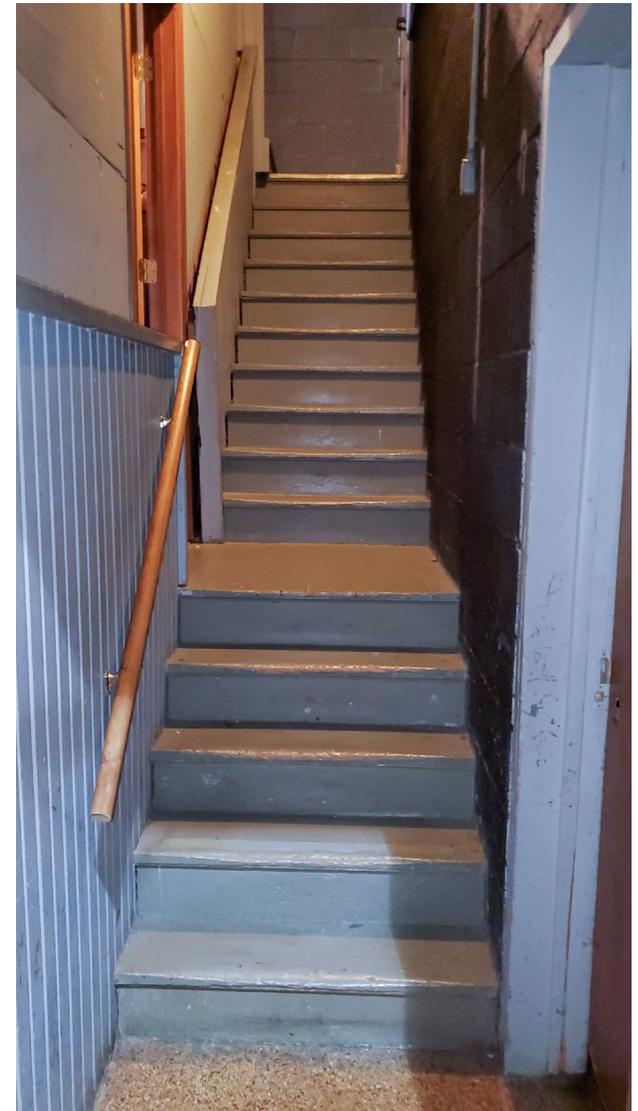
Fig. 11, Left: Both of the 1949 stairs connecting upper level rooms adjacent to the gymnasium have numerous code issues and would need complete replacement. Issues include non-compliant handrails, non-compliant landings, lack of clear space at doorways, and a stair rise and run that is steeper than code allows.

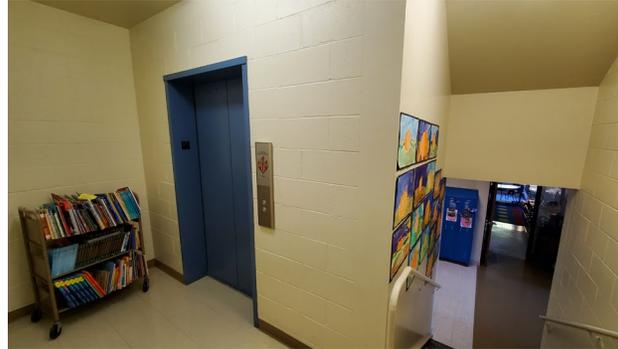
Fig. 1: The elevator and stair landing is not enclosed with fire-rated doors and does not have a two-way communication device for a disabled individual to call for help, which is required for non-sprinkled buildings.

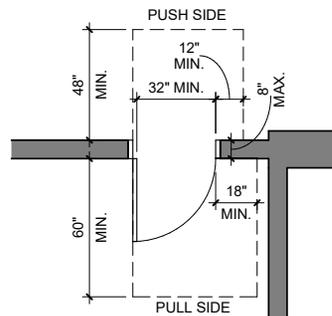
Above Left, Fig. 4: Standard ADA door clearance requirements

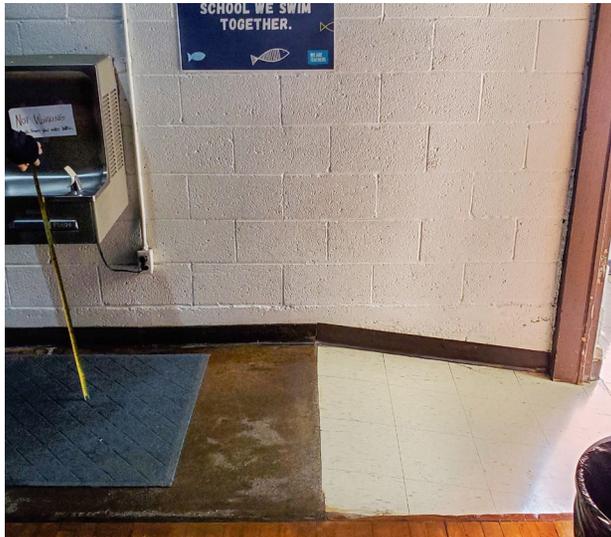
Fig. 10: A non-compliant ramp that is steeper than allowed by ADA for an accessible route. A drinking fountain projects out greater than 4" into the accessible route, which is also not allowed by ADA.

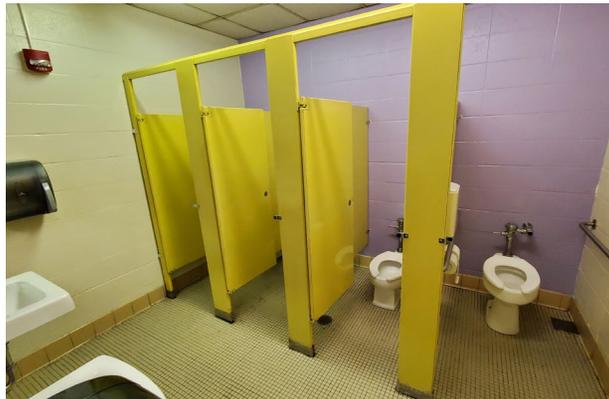
Fig. 17: A girls restroom adjacent to the 1960 classroom wing that does not have a wheelchair-accessible stall, adequate wheelchair turning radius, or compliant grab bars. Exposed piping under sinks must be covered with a protective shroud to prevent burns by wheelchair users.

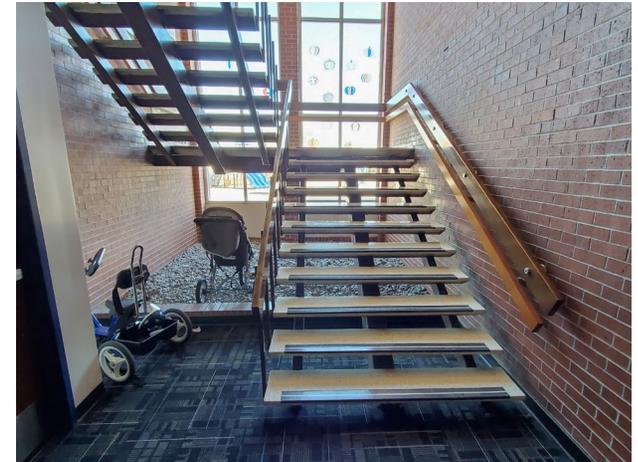
Fig. 16: Both stairs constructed in 1973 do not meet ADA requirements for handrails and guardrails, and the stair adjacent to the administration office contains open risers which are not permitted.

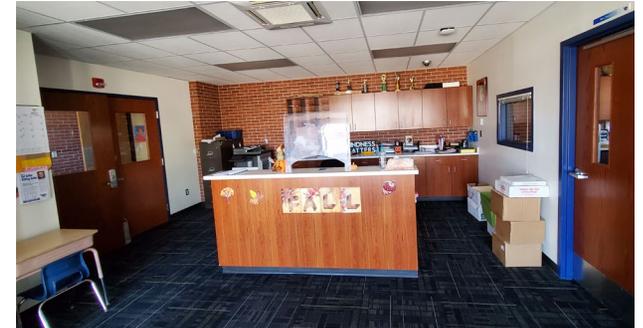
Fig. 20: The reception casework in the administration office does not have an ADA-accessible transaction counter.

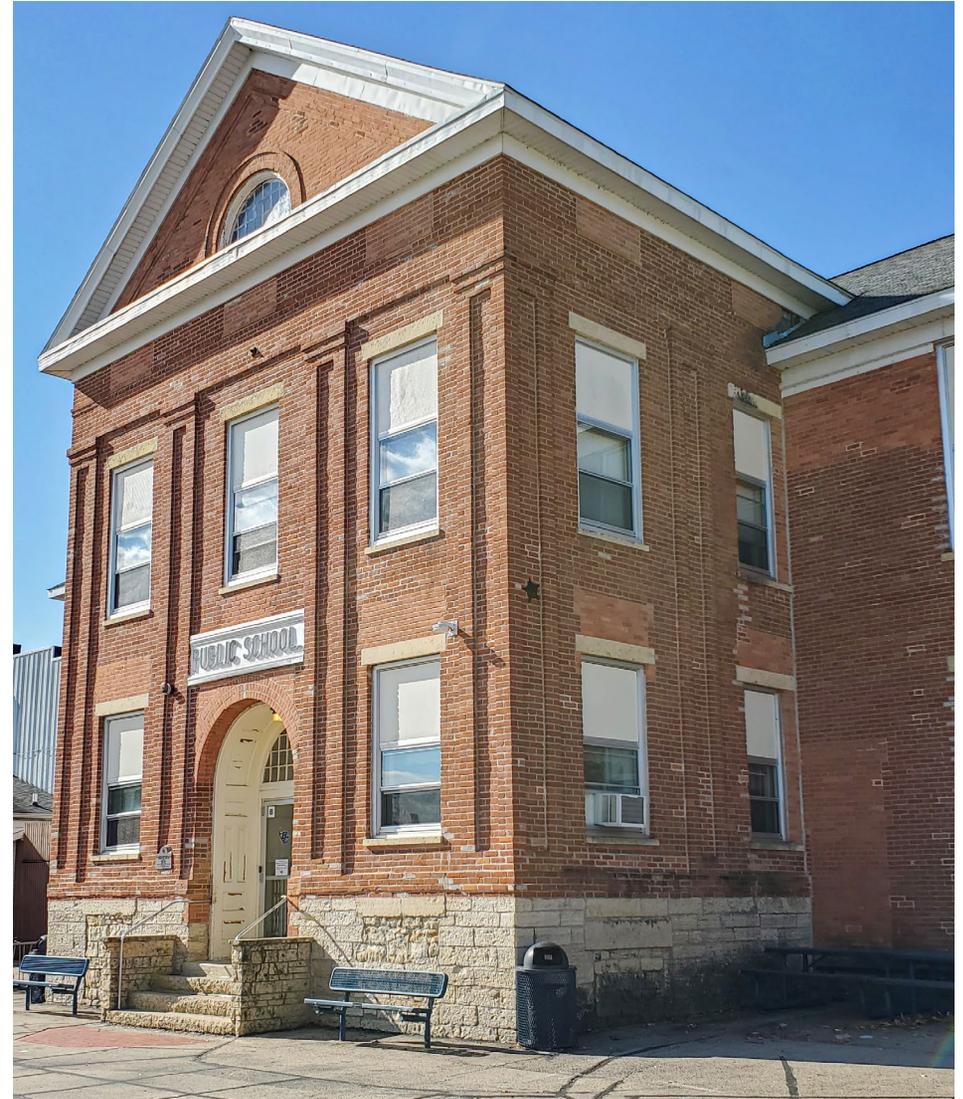
Fig. 1: Newer single-pane operable windows and older single-pane arched windows. Building cornices do not have gutters and allow water to drip onto wall surfaces, which is causing moisture issues at the base of the building.

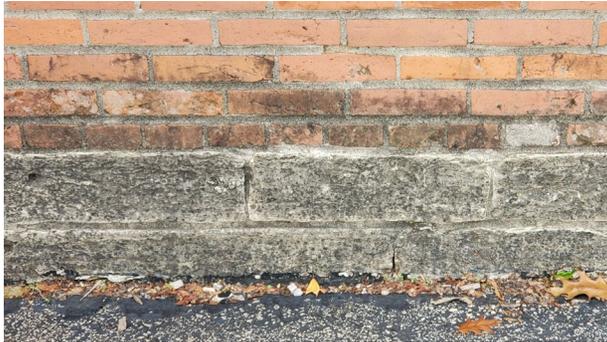
Left, Fig. 2: Mold and mildew growth at base of brick and limestone foundation.

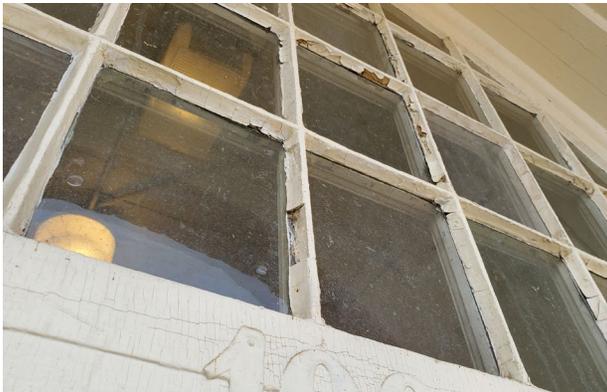
Fig. 3: Arched single-pane window on 1848 building with possible asbestos putty.

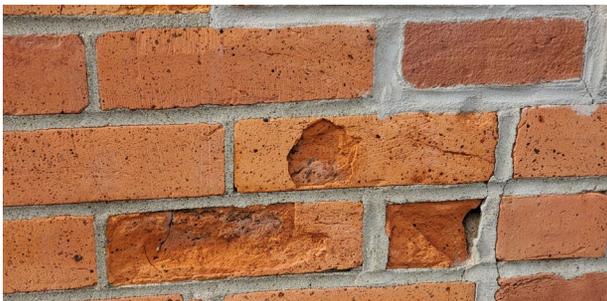
Fig. 4: Spalling brick on the 1848 exterior wall.

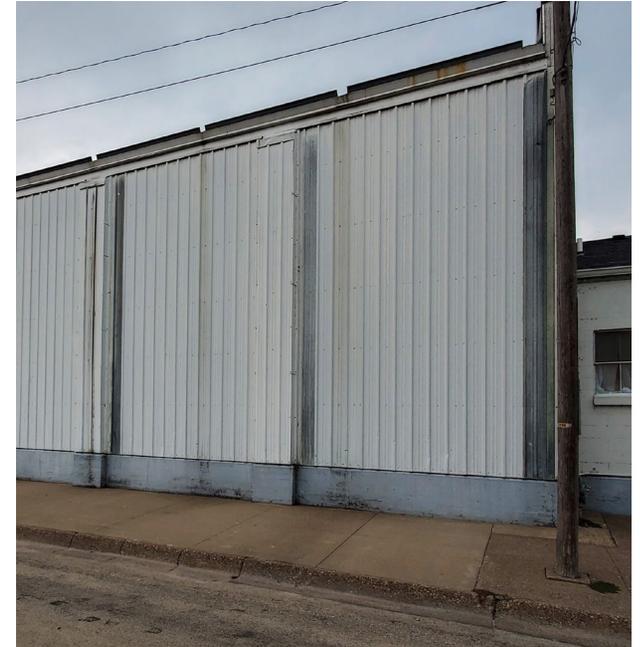
Fig. 5: Water sheds directly off roof and onto gym siding below, as can be seen by streaking on the siding and mildew growth on the foundation.

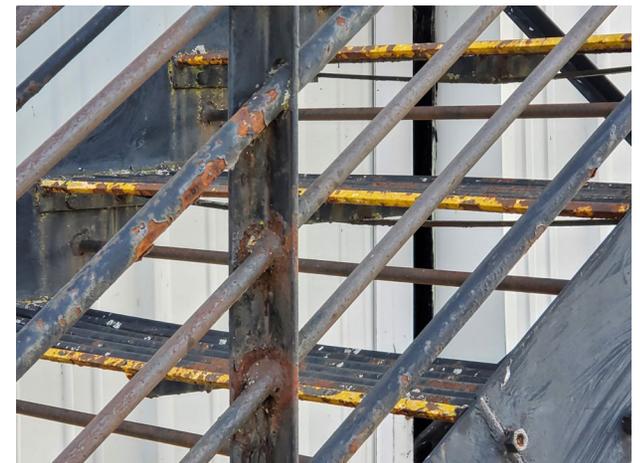
Fig. 6: Gym fire escape in poor condition

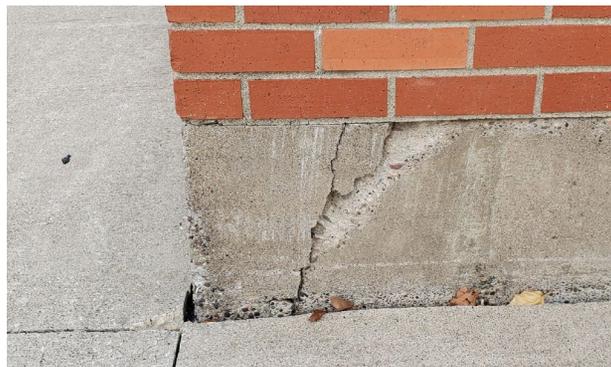
Fig. 7: Cracking and spalling concrete foundation on the 1960 addition

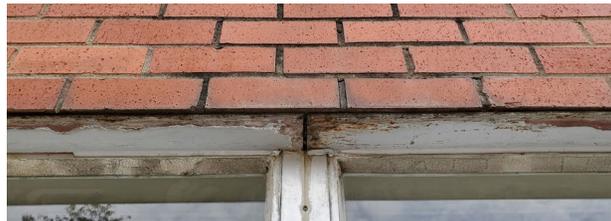
Fig. 8: Damage to window head lintels due to water intrusion into the brick cavity on the 1960 addition. Cracking window gaskets are also visible.

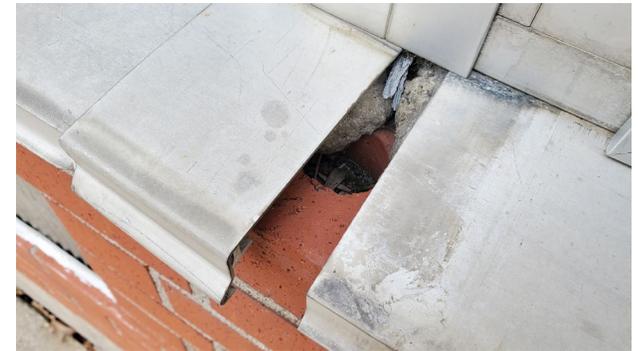
Fig. 9: Damaged window sill in 1960 addition, allowing water and pests into wall cavity

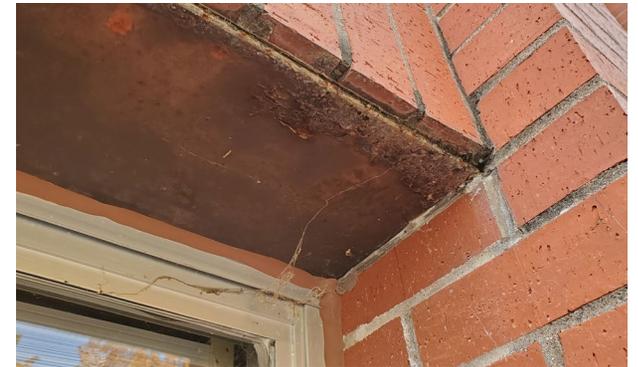
Fig. 10: Rusting steel lintel on the 1973 addition

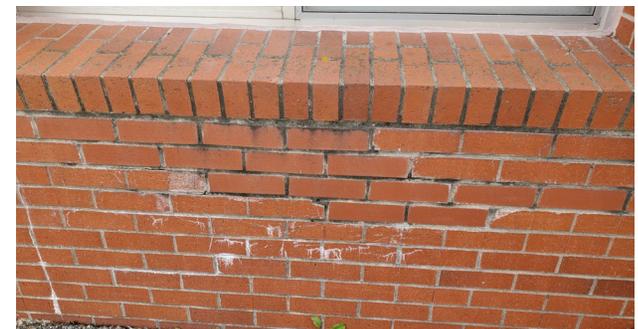
Fig. 11: Water intrusion into the 1973 brick window sill, resulting in mold, mildew, efflorescence, and deterioration of the brick and mortar.

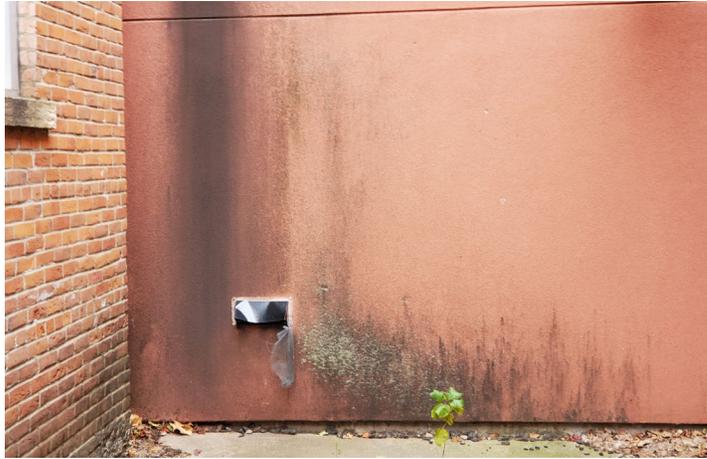
Fig. 12: Mold and mildew growth on the 2005 elevator addition EIFS panels due to a lack of gutters on the 1848 building.

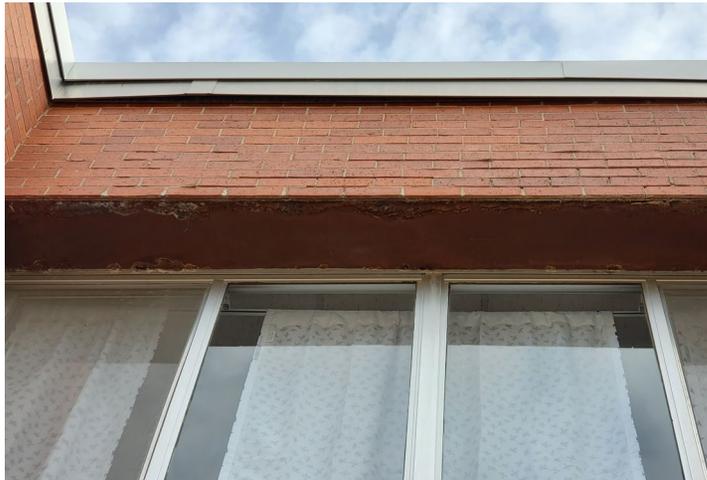
Fig. 13: Galvanic action occurring between the steel lintel and aluminum windows on the 1973 addition, which causes accelerated corrosion of both metals. Water intrusion into the brick above is also causing significant rust on the lintel and damage to the mortar.

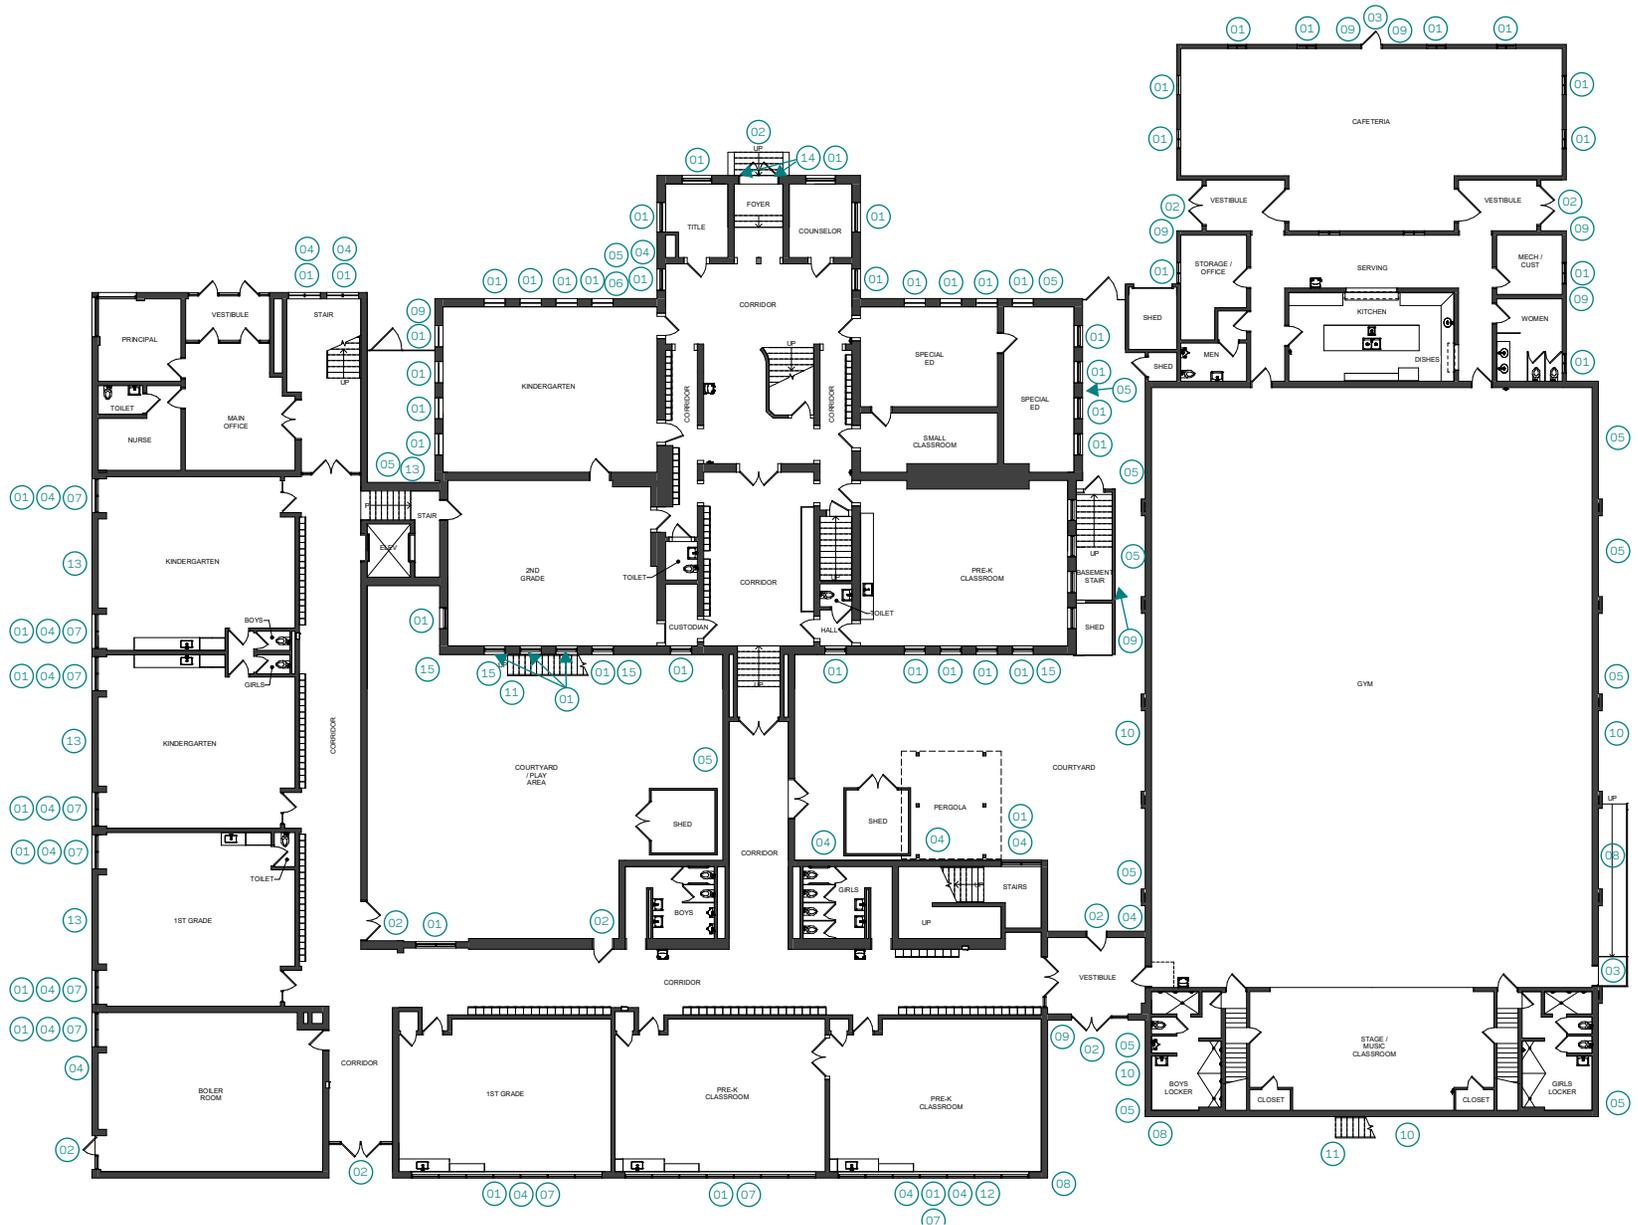
# Exterior Conditions - Second Floor Plan

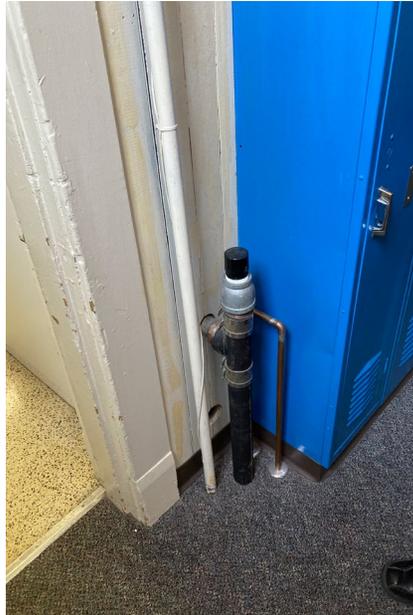
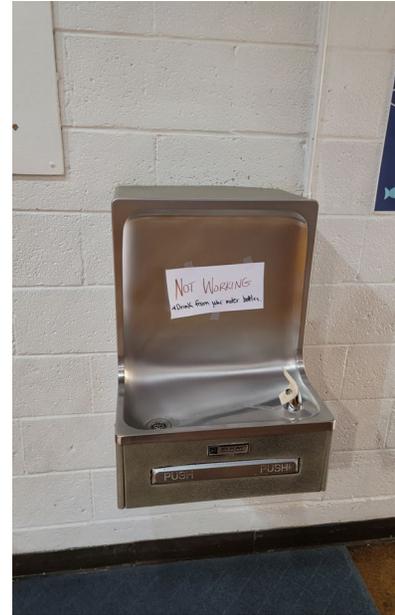
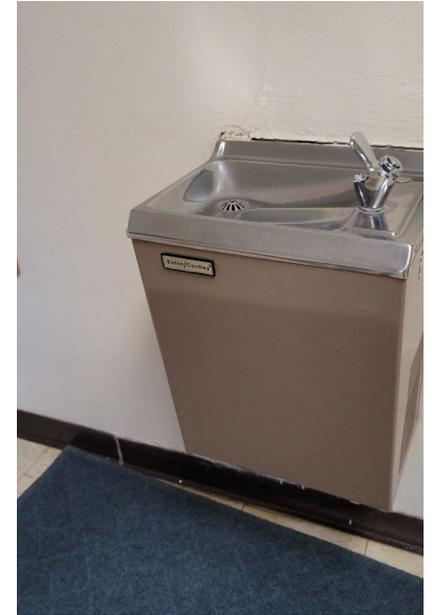
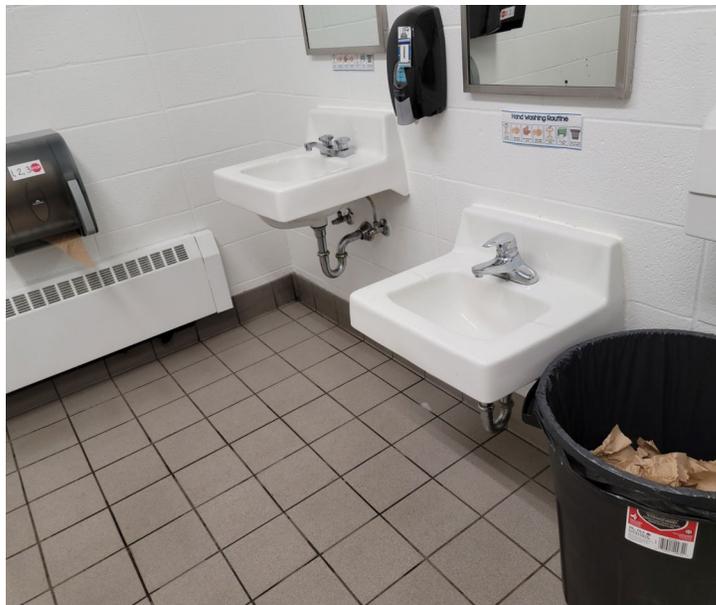
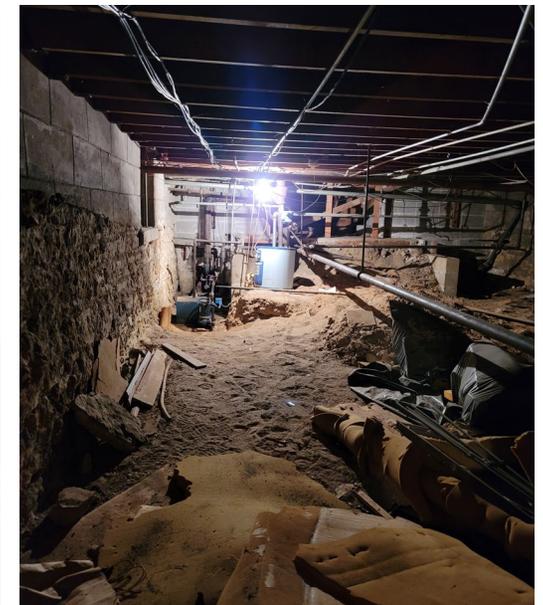
# Mechanical - Code Compliance and System Condition

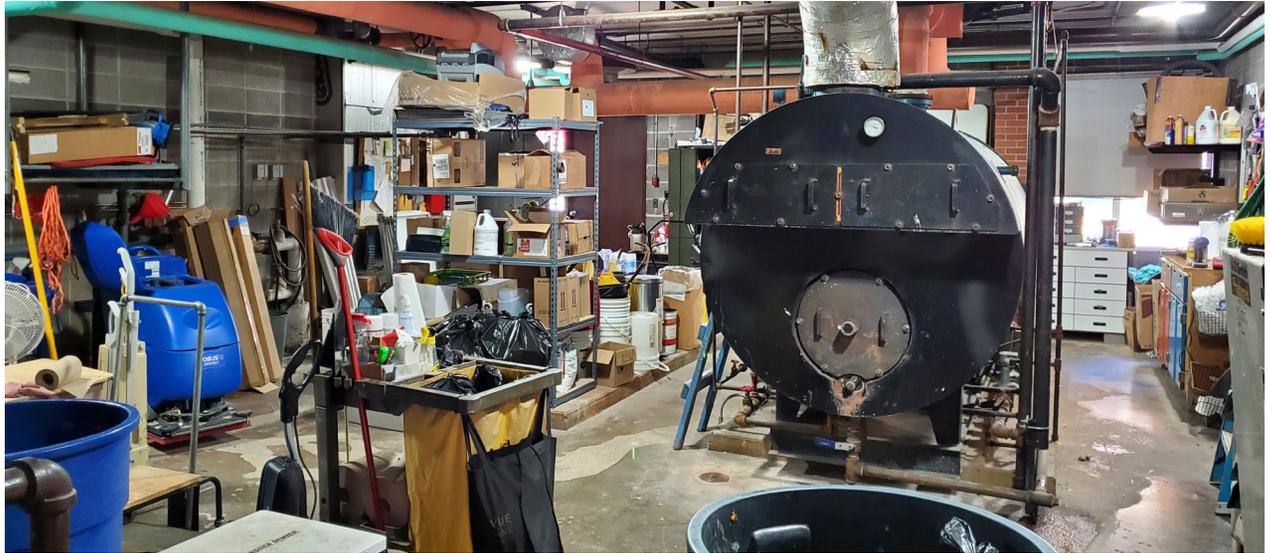
Boiler room in the 1973 addition.

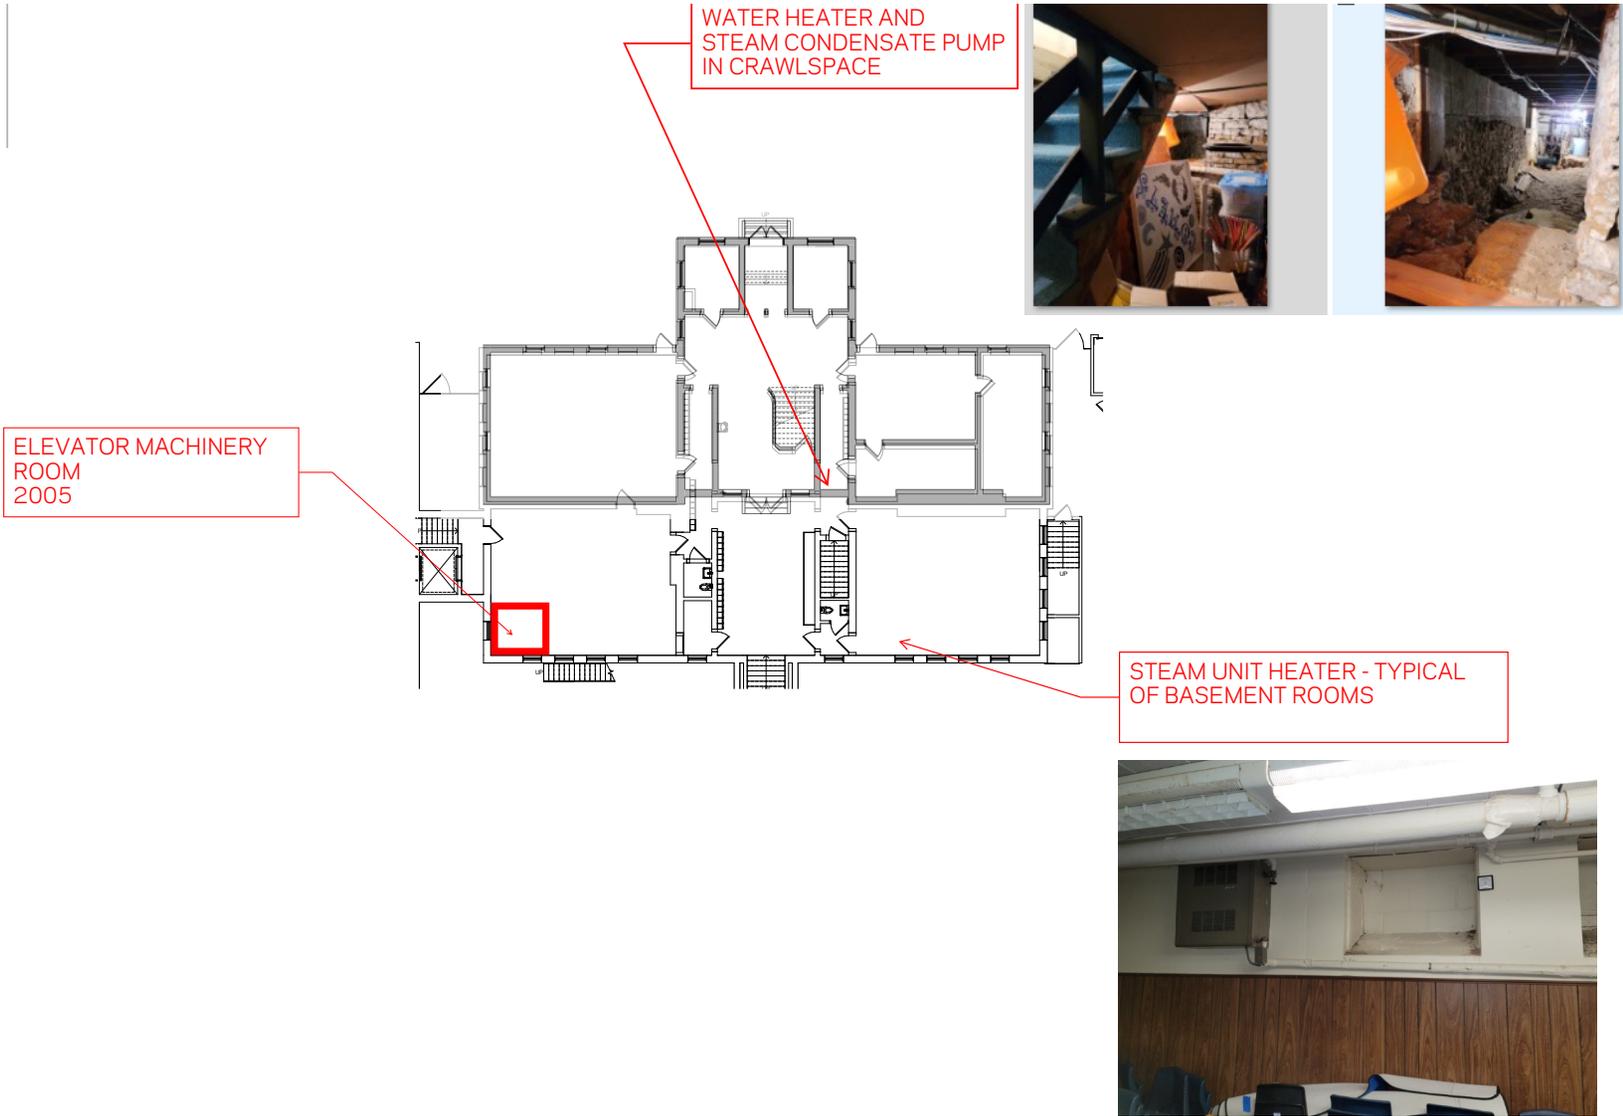
# Mechanical - First / Second Floor

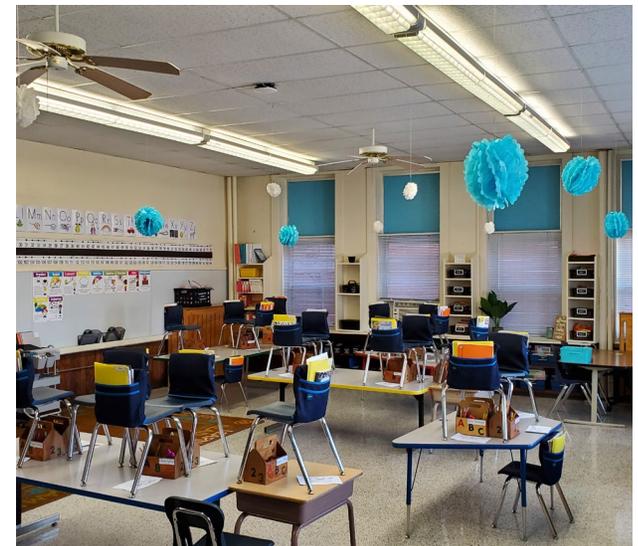
Mid-20th century fluorescent lighting in one of the 1848 classrooms.
