Work Session Meeting Information

BELLEVUE COMMUNITY SCHOOL DISTRICT

Executive Summary

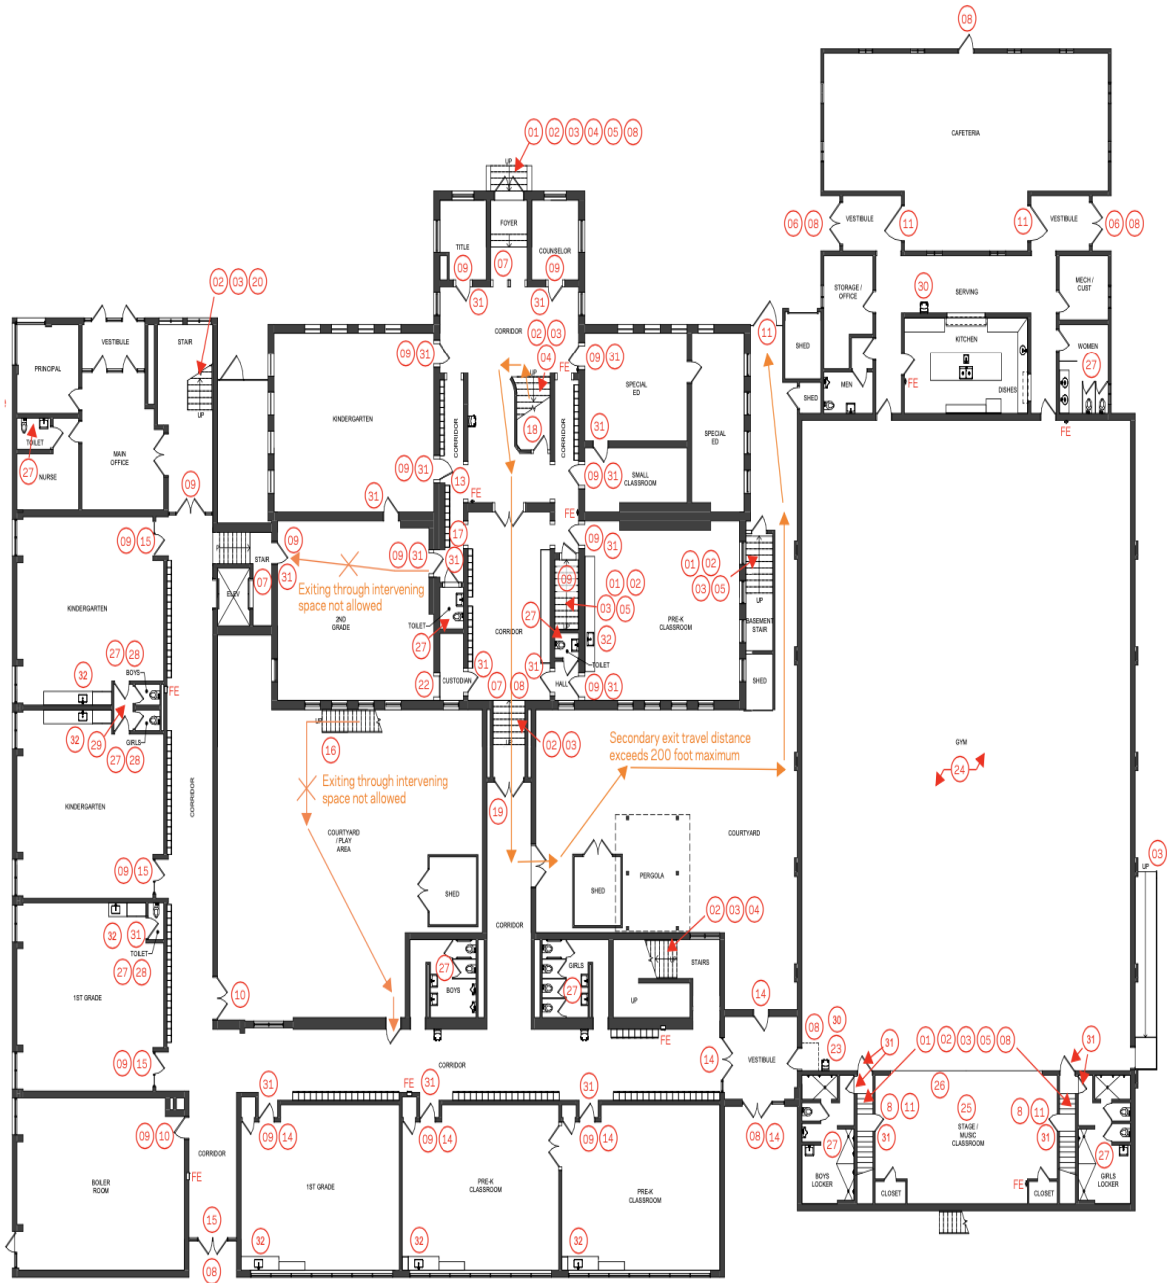
Code Compliance Plan - First Floor

01. Non-compliant stair rise or run (2015 IBC)
02. Non-compliant handrail (2015 IBC)
03. Non-compliant or non-existent handrail extensions (2015 IBC)
04. Non-compliant guardrail (2015 IBC)

05. Non-compliant stair landing (2015 IBC)
06. Non-compliant ramp (2015 IBC)
07. Non-compliant area of refuge for persons with mobility impairments during a fire (2015 IBC)

08. Non-accessible exit (2015 IBC)
09. Door and/or window not properly fire-rated (2015 IBC)
10. Door swings in wrong direction for egress (2015 IBC)
11. Non-compliant door egress or access hardware (2015 IBC)

12. Door width non-compliant (2015 IBC)
13. Door swing reduces width of corridor / opening by more than 50% (2015 IBC)
14. Glass not tempered (2015 IBC)
15. Wire glass not allowed (2015 IBC)

16. Egress into enclosed courtyard not allowed (2015 IBC)
17. Exit corridor width less than code allows (2015 IBC)
18. No fire separation between basement and upper levels (2015 IBC)

19. Improperly labeled exits (2015 IBC)
20. Open stair risers not allowed (2015 IBC)
21. Exit corridor space being used as library storage
22. Remove abandoned door and replace with fire-rated wall assembly (2015 IBC)

23. Object impedes clear egress space (2015 IBC)
24. Gaps in structural fireproofing (2015 IBC)
25. Music classroom not wheelchair accessible (ICC 117.1)

26. Stage curtain not fire-rated (2015 IBC)
27. Non-accessible restroom (ICC 117.1)
28. Non-compliant door swing into toilet room (2015 IPC)
29. Non-accessible hallway (ICC 117.1)

30. Non-accessible drinking fountain (ICC 117.1)
31. Non-accessible door clearance (ICC 117.1)
32. Non-accessible sink (ICC 117.1)
33. S-1 storage space required to have fire-rated walls, doors, and floor below (IBC 2015)

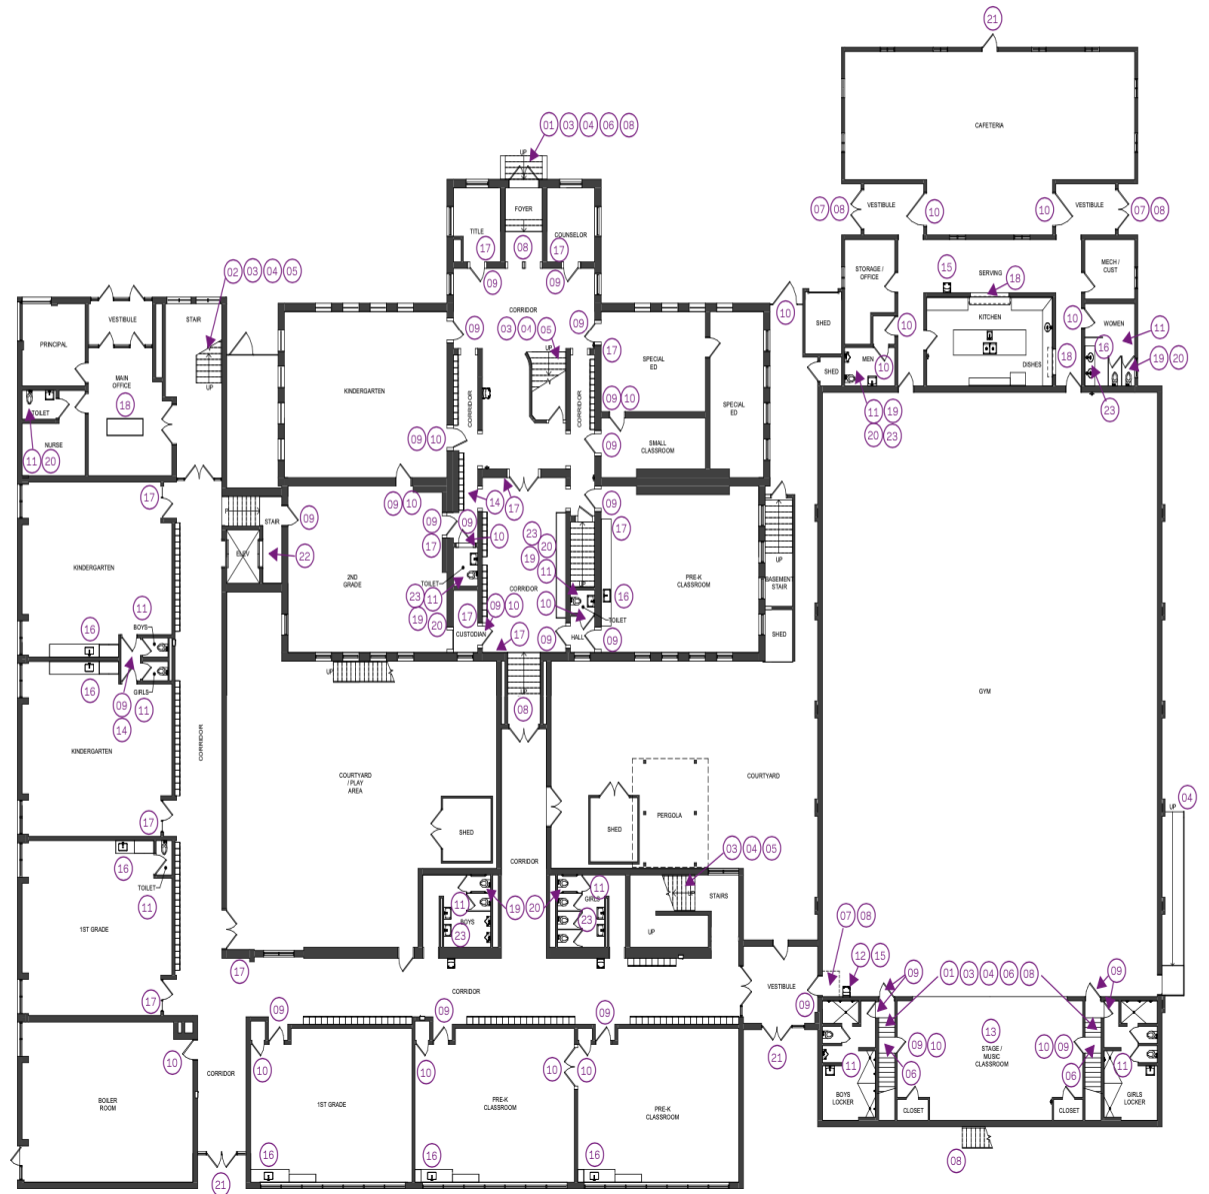
ADA Compliance — First Floor

01. Non-compliant stair rise or run
02. Non-compliant stair risers
03. Non-compliant handrail
04. Non-compliant or non-existent handrail extensions
05. Non-compliant guardrail

06. Non-compliant stair landing
07. Non-accessible ramp
08. Non-accessible exit
09. Non-accessible door clearance
10. Non-accessible door hardware
11. Non-accessible restroom

12. Object protrudes greater than 4 inches into accessible route
13. Classroom space is not wheelchair accessible
14. Corridor / hallway does not have accessible clearances

15. Non-accessible drinking fountain
16. Non-accessible sink / cabinet
17. Wall device mounted higher than allowed for accessibility
18. Non-accessible counter / transaction surface

19. Missing or non-compliant toilet grab bars
20. Toilet clear space not compliant for accessibility
21. Change in elevation / step exceeds 1/4" - not an accessible doorway

22. Elevator landing does not have required turning radius
23. No protective shroud at sinks

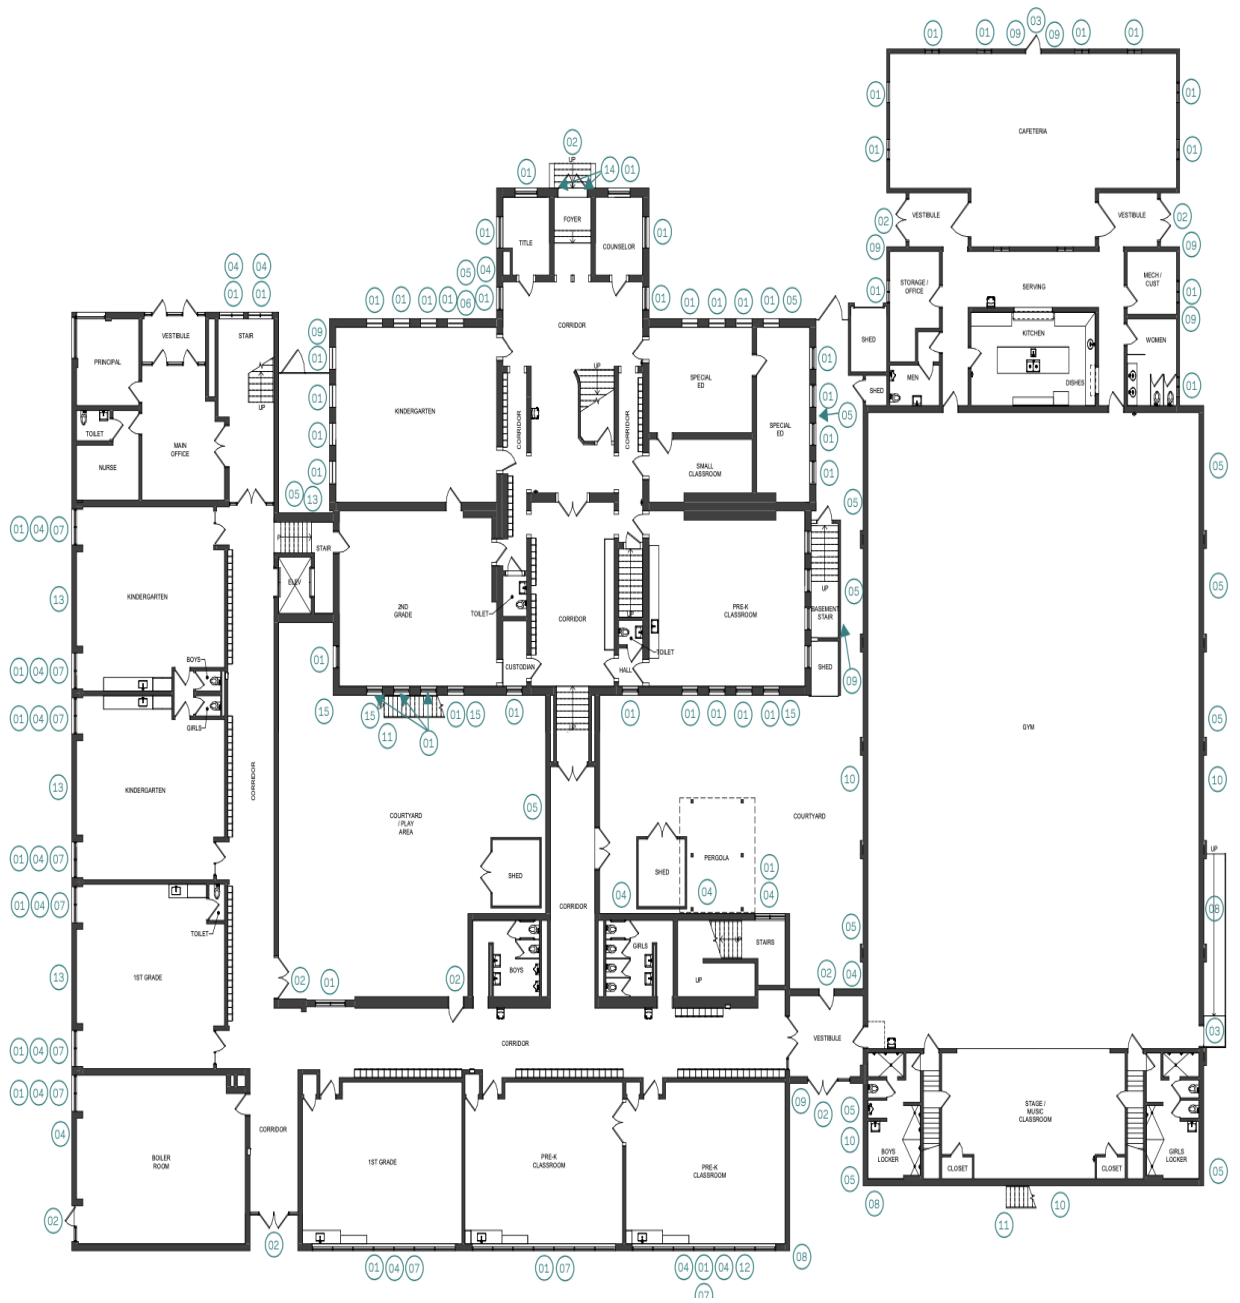
Exterior Conditions - First Floor Plan

01. Single-pane, non-insulated windows
02. Single-pane, non-insulated and non-tempered door glass
03. Non-insulated hollow metal door
04. Brick moisture issues / efflorescence
05. Mold / mildew growth on wall due to lack of gutters
06. Limestone spalling
07. Rust / corrosion on structural lintels
08. Cracking foundation
09. Crack in exterior wall
10. Metal siding in poor condition / no insulation
11. Exit stair in poor condition / rust
12. Damaged window sill / exposed wall cavity
13. Damaged mechanical louvers
14. Paint flaking off wood jambs
15. Parge coating at base of wall failing
