### Work Session Meeting Information

MODUS Engineering and OPN Architects shared their assessment of the elementary school. The group clarified and responded to information that was shared in a written report (on the website).

In August 2021, OPN Architects and MODUS Engineering met with Superintendent Tom Meyer and Maintenance Director Brett Ernst to tour the existing Bellevue Elementary School facility. Following this meeting, OPN and MODUS were selected by district leadership to perform a facility assessment. A kick-off meeting to initiate the process and discuss details of the assessment was held in September 2021. Detailed observation visits were performed in late October and early November 2021. Deficiencies related to code, ADA accessibility, building condition, and mechanical and electrical systems were recorded and are compiled in this report (December 2021).

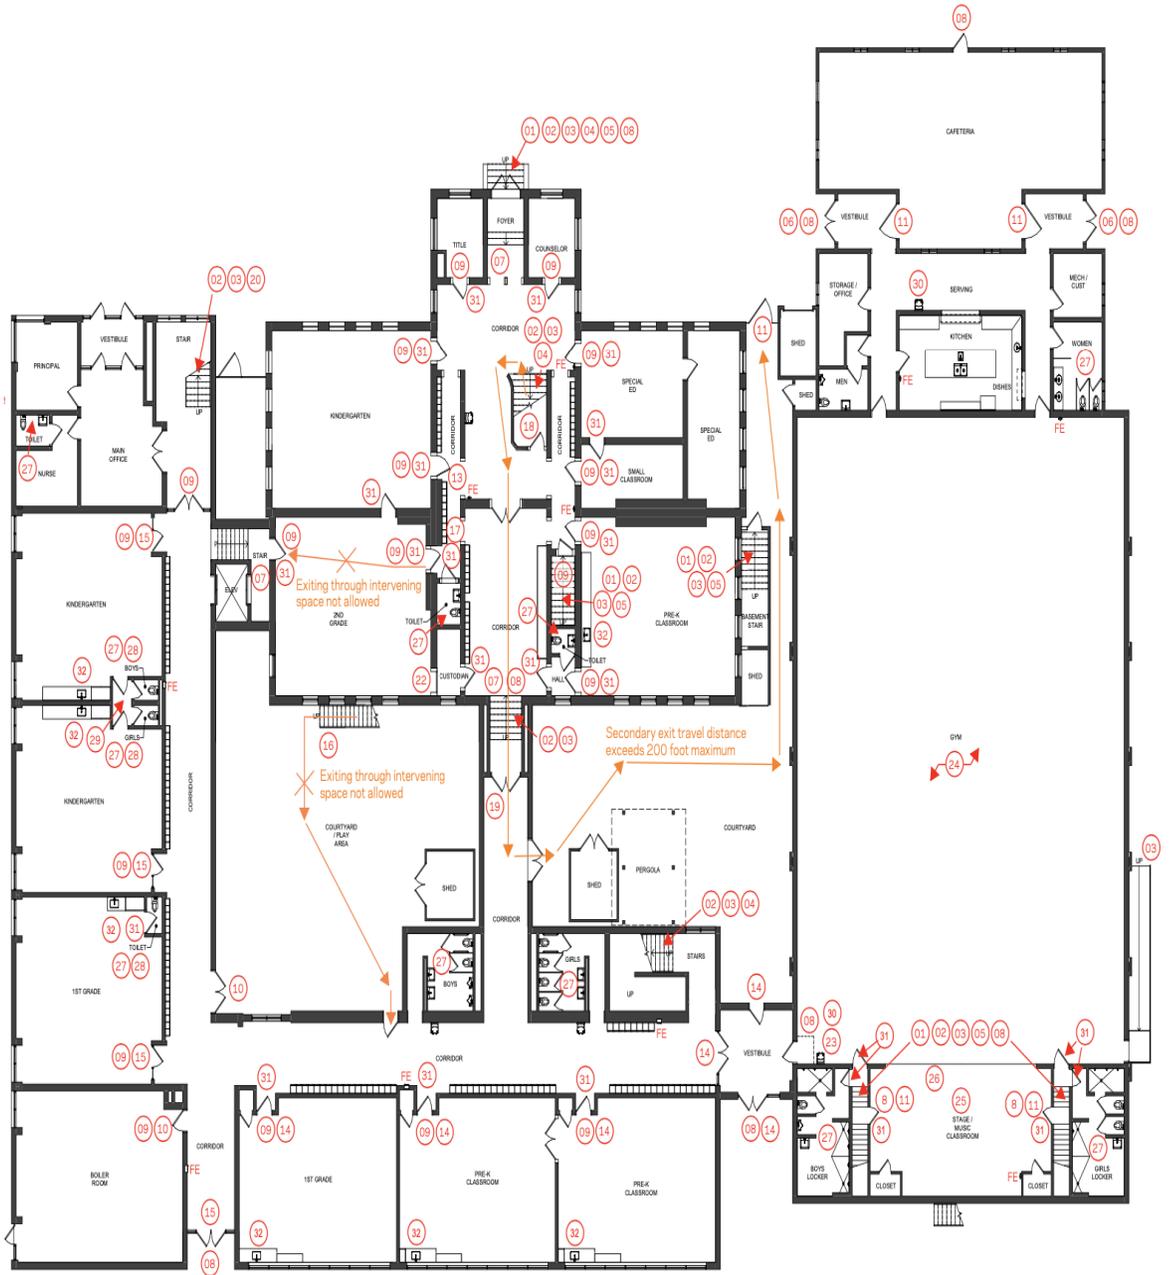
# Code Compliance Plan - First Floor

01. Non-compliant stair rise or run (2015 IBC)
02. Non-compliant handrail (2015 IBC)
03. Non-compliant or non-existent handrail extensions (2015 IBC)
04. Non-compliant guardrail (2015 IBC)

05. Non-compliant stair landing (2015 IBC)
06. Non-compliant ramp (2015 IBC)
07. Non-compliant area of refuge for persons with mobility impairments during a fire (2015 IBC)

08. Non-accessible exit (2015 IBC)
09. Door and/or window not properly fire-rated (2015 IBC)
10. Door swings in wrong direction for egress (2015 IBC)
11. Non-compliant door egress or access hardware (2015 IBC)

12. Door width non-compliant (2015 IBC)
13. Door swing reduces width of corridor / opening by more than 50% (2015 IBC)
14. Glass not tempered (2015 IBC)
15. Wire glass not allowed (2015 IBC)

16. Egress into enclosed courtyard not allowed (2015 IBC)
17. Exit corridor width less than code allows (2015 IBC)
18. No fire separation between basement and upper levels (2015 IBC)

19. Improperly labeled exits (2015 IBC)
20. Open stair risers not allowed (2015 IBC)
21. Exit corridor space being used as library storage
22. Remove abandoned door and replace with fire-rated wall assembly (2015 IBC)

23. Object impedes clear egress space (2015 IBC)
24. Gaps in structural fireproofing (2015 IBC)
25. Music classroom not wheelchair accessible (ICC 117.1)

26. Stage curtain not fire-rated (2015 IBC)
27. Non-accessible restroom (ICC 117.1)
28. Non-compliant door swing into toilet room (2015 IPC)
29. Non-accessible hallway (ICC 117.1)

30. Non-accessible drinking fountain (ICC 117.1)
31. Non-accessible door clearance (ICC 117.1)
32. Non-accessible sink (ICC 117.1)
33. S-1 storage space required to have fire-rated walls, doors, and floor below (IBC 2015)

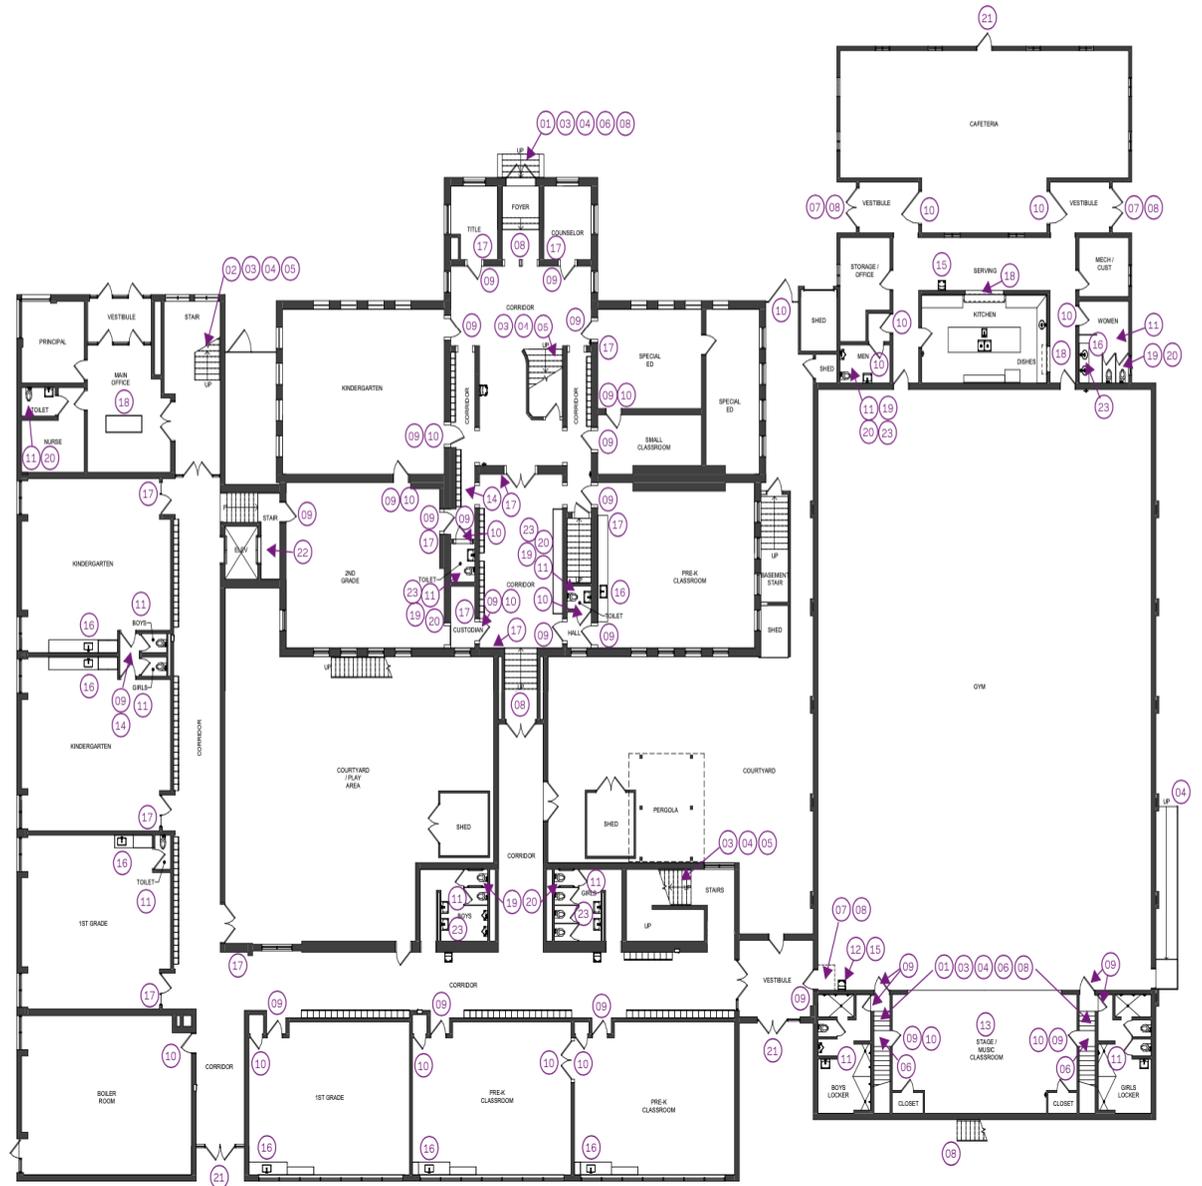
# ADA Compliance — First Floor

01. Non-compliant stair rise or run
02. Non-compliant stair risers
03. Non-compliant handrail
04. Non-compliant or non-existent handrail extensions
05. Non-compliant guardrail

06. Non-compliant stair landing
07. Non-accessible ramp
08. Non-accessible exit
09. Non-accessible door clearance
10. Non-accessible door hardware
11. Non-accessible restroom

12. Object protrudes greater than 4 inches into accessible route
13. Classroom space is not wheelchair accessible
14. Corridor / hallway does not have accessible clearances

15. Non-accessible drinking fountain
16. Non-accessible sink / cabinet
17. Wall device mounted higher than allowed for accessibility
18. Non-accessible counter / transaction surface

19. Missing or non-compliant toilet grab bars
20. Toilet clear space not compliant for accessibility
21. Change in elevation / step exceeds 1/4" - not an accessible doorway

22. Elevator landing does not have required turning radius
23. No protective shroud at sinks

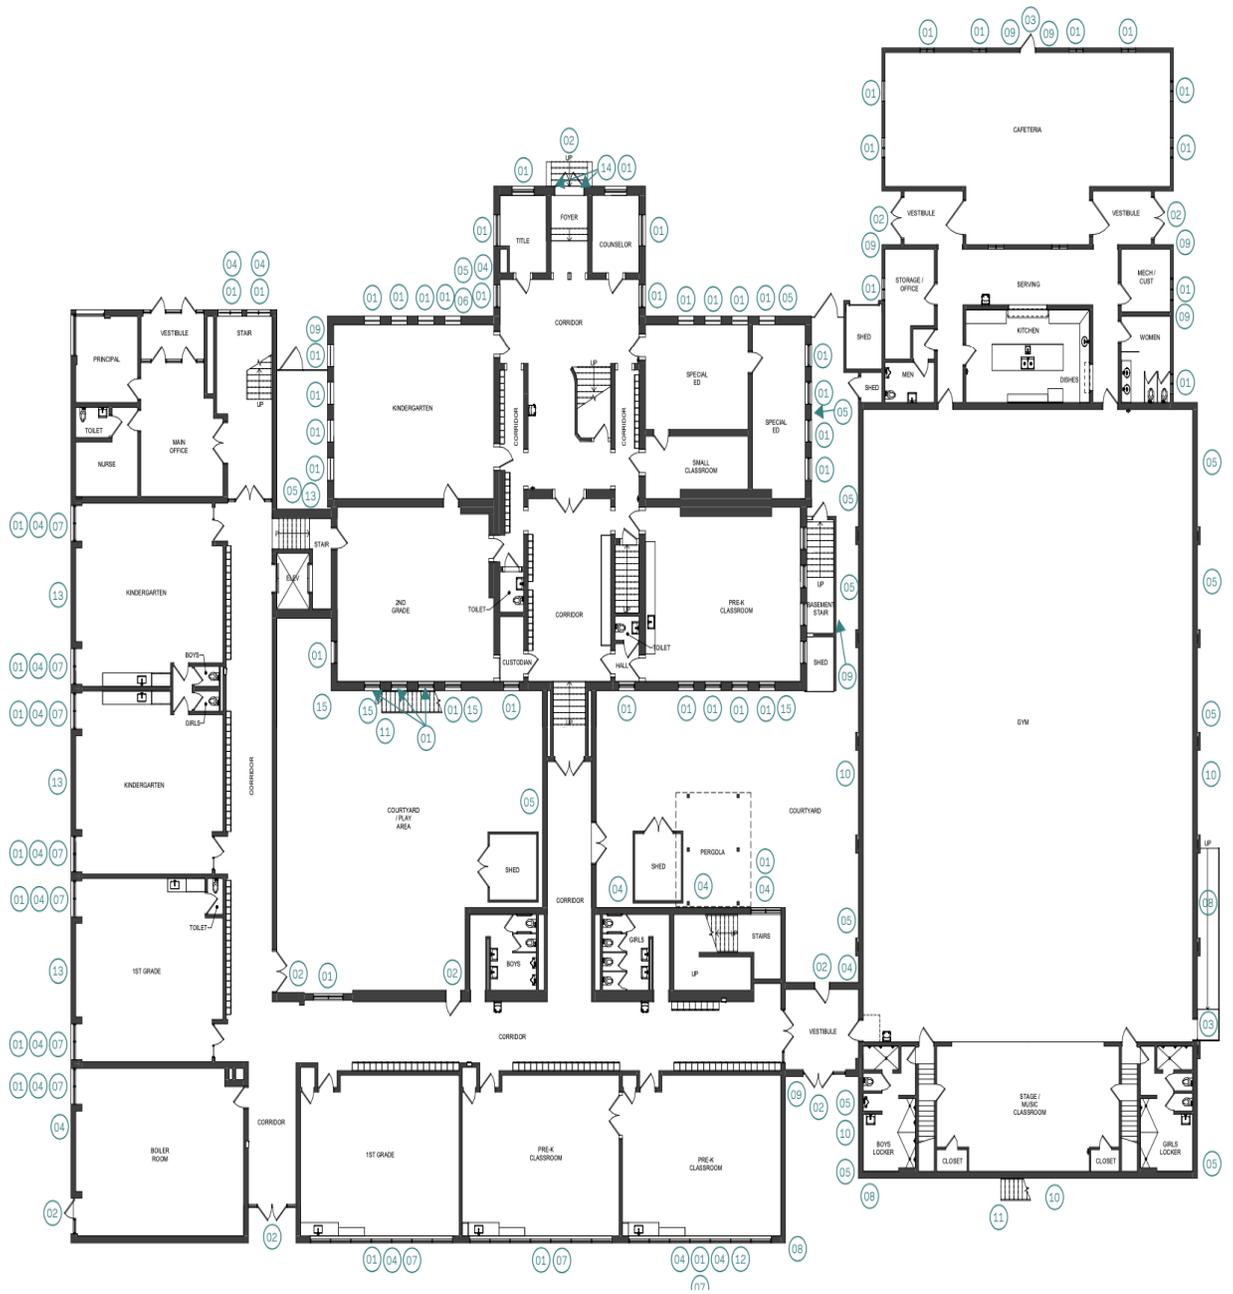
# Exterior Conditions - First Floor Plan

01. Single-pane, non-insulated windows
02. Single-pane, non-insulated and non-tempered door glass
03. Non-insulated hollow metal door
04. Brick moisture issues / efflorescence
05. Mold / mildew growth on wall due to lack of gutters
06. Limestone spalling
07. Rust / corrosion on structural lintels
08. Cracking foundation
09. Crack in exterior wall
10. Metal siding in poor condition / no insulation
11. Exit stair in poor condition / rust
12. Damaged window sill / exposed wall cavity
13. Damaged mechanical louvers
14. Paint flaking off wood jambs
15. Parge coating at base of wall failing
