Work Session Meeting Information

BELLEVUE COMMUNITY SCHOOL DISTRICT

Executive Summary

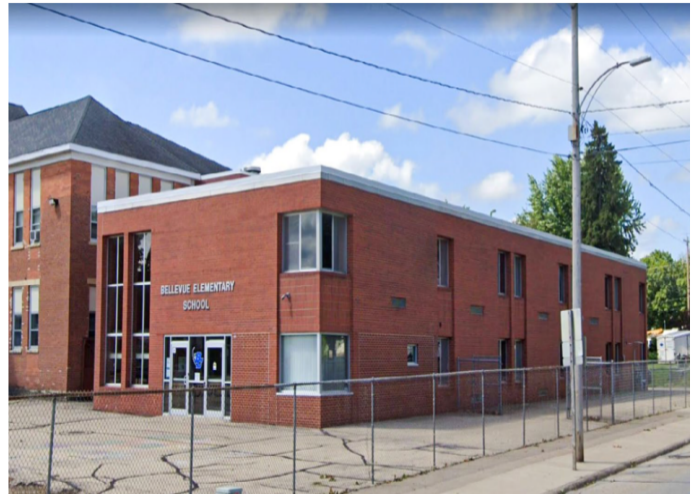
Due to the age and condition of the existing electrical service, it should be replaced with a new 208/120V, 3Ø, 4-wire 800-amp distribution panel with a surge protection device and appropriate quantity and rating of breakers. Additional branch panels may need to be replaced one-for-one to update branch circuit grounding requirements and allow for additional breaker space.

In several classrooms there are charging stations for student laptops. More power and receptacles should be added in these areas to accommodate for charging station needs.
