### Work Session Meeting Information

MODUS Engineering and OPN Architects shared their assessment of the elementary school. The group clarified and responded to information that was shared in a written report (on the website).

In August 2021, OPN Architects and MODUS Engineering met with Superintendent Tom Meyer and Maintenance Director Brett Ernst to tour the existing Bellevue Elementary School facility. Following this meeting, OPN and MODUS were selected by district leadership to perform a facility assessment. A kick-off meeting to initiate the process and discuss details of the assessment was held in September 2021. Detailed observation visits were performed in late October and early November 2021. Deficiencies related to code, ADA accessibility, building condition, and mechanical and electrical systems were recorded and are compiled in this report (December 2021).

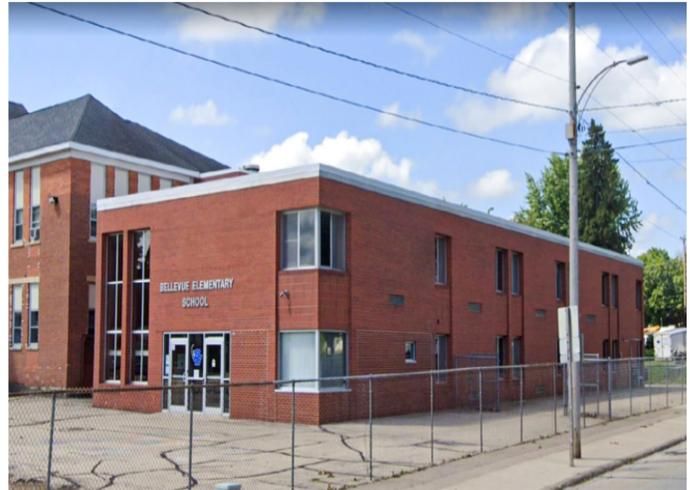
Due to the age and condition of the existing electrical service, it should be replaced with a new 208/120V, 3Ø, 4-wire 800-amp distribution panel with a surge protection device and appropriate quantity and rating of breakers. Additional branch panels may need to be replaced one-for-one to update branch circuit grounding requirements and allow for additional breaker space.
